Evaluation Structural Strength for Beams and Two-Way Roof Slab Systems using Core Test and load Test and Analyzing the Causes of Their Failure.

Mohammad A. Al Zuhaili¹, Khalid Y. A. Al Mazrouei²

In this research a site evaluation preformed on two-way solid roof slabs for two villas, to identify the load level for each structure and causes of failure, with consideration to the design and Implementation of Load Test and Core Test, also its focuses on evaluation criteria and their significance, limitations and applicability. Those structure elements were chosen carefully to represent an ideal case study. Site evaluation shows a deflection in the center and diffuse cracks in top and Bottom faces of slabs, the slabs dimension is (6.90 m x 5.25 m, 6.00 m x 6.20 m) and it supported by beams (6.00 m x 5.00 m).

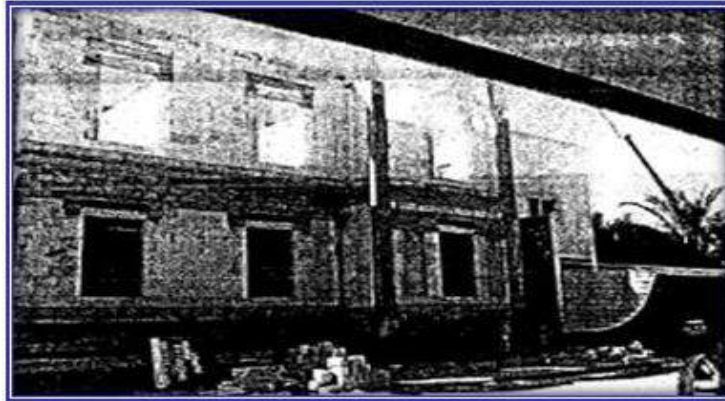
Figure 1 General view of the building

A typical concrete frame and brick walls house, consists of basement, ground, 1st and 2nd floor. The building was constructed in conventional method, built from reinforcement concrete and the cement block walls (Figure 1, 2, 3). This study is carried out to assess the

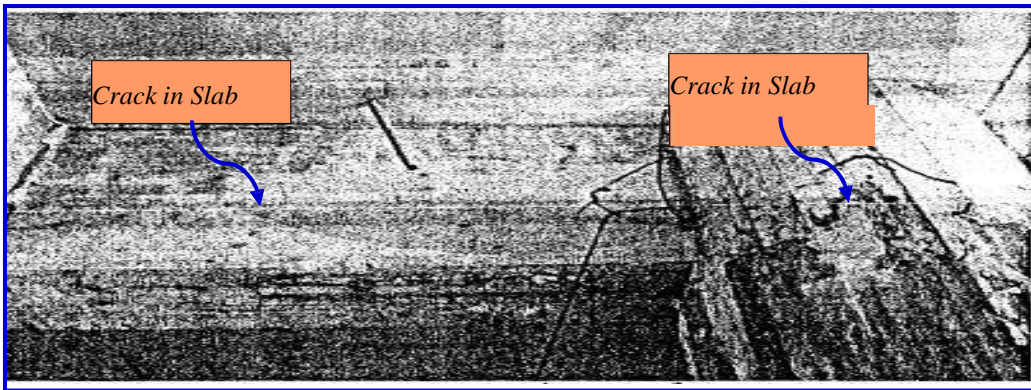
- Inclined cracks in some beams type B17, CB1 and CB5 in the ground roof.
- Cracks in some slabs, at the bottom in the ground roof (Figure 4).
- Changes in the color of the concrete slab roof in various places (Figure 5)
- Vertical cracks in beam B3 (Figure 6).

Figure 4 Cracks at the bottom of the slabs

It is clear from the study that the thickness of the slabs is insufficient as well as the reinforcing steel in both directions. Absence of upper reinforcement steel, resulting in cracks around the slabs and the sides of the beams, as there is no reinforcing in the corners of the slabs causing additional cracks. The reduction of the cross-sectional reinforcing steel in the B11 and the CB5 beam was also shown to be unsafe due to the design and the weakness of the concrete, resulting in clear cracks. It is noted from the design that the slabs are designed as *simple support* and should be designed as *continuous slabs* with the knowledge that the reinforcing steel is properly positioned and properly designed. The upper reinforcing steel was not extended to 22% of the larger beam's length in the adjacent beam, which is failure to follow ACI-318 design code.

The study shows that the structural elements in the building need supporting and strengthening to enable the building to carry out the structural role required to ensure the structural safety required for the building: The repair process should be designed for defective structural elements by a consulting engineering firm specializing in repairs Beams and slabs in which a landing by a specialized company and engineering supervision should be repaired.

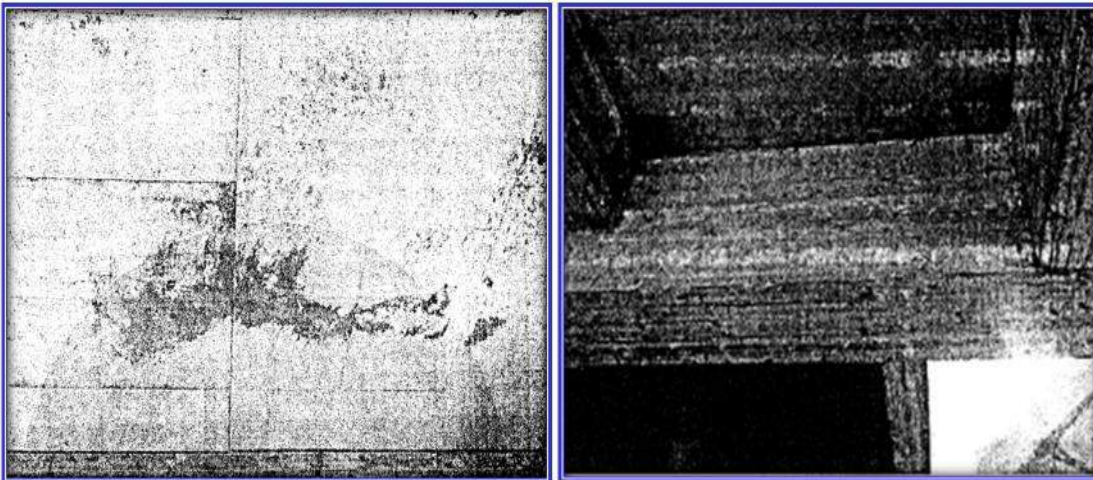
Figure 5 Changes in the color of the concrete slab

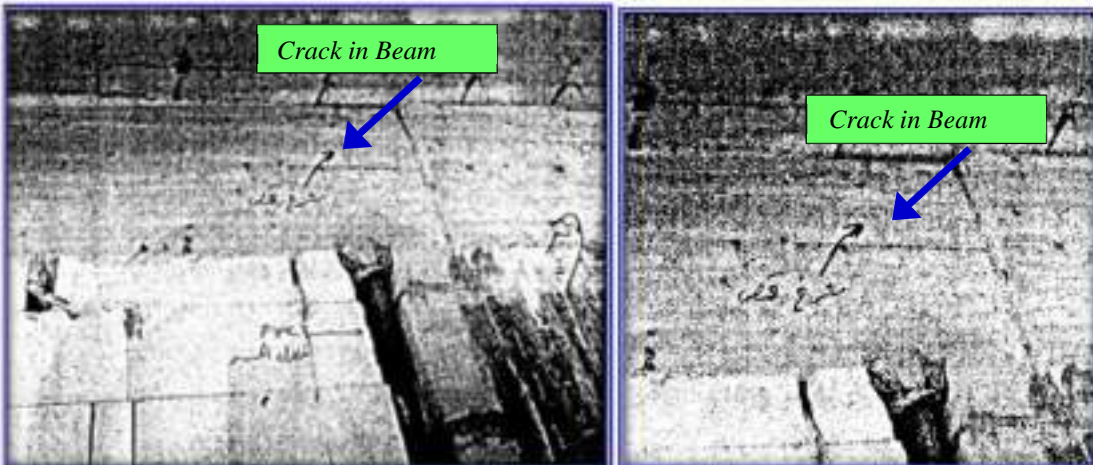
Figure 6 Cracks in the beams

In the first building (Bayan), beams should be supported by steel beams to support the structure to withstand the loads. Cracks should be repaired by epoxy products. The second building (Salmiyah), slabs (S5, S8, S9) should be demolished and recasting concrete accordance to ACI-318 specifications.

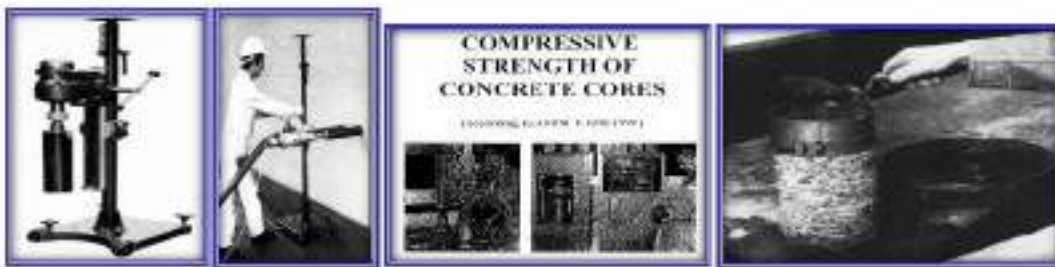
Five concrete samples core was taken from various places in the building (3 samples from the beams and 2 from the ground roof slab) to determine the concrete's ability to bearing the compressive strength of concrete and its quality. And for measure the actual strength of the concrete. They were examined after 24 hours from extraction. The following table shows the detailed results of concrete samples (Figure 7, 8, Table 1)

Figure 7 Instruments of concrete core test (according to ASTM C42M-1999)

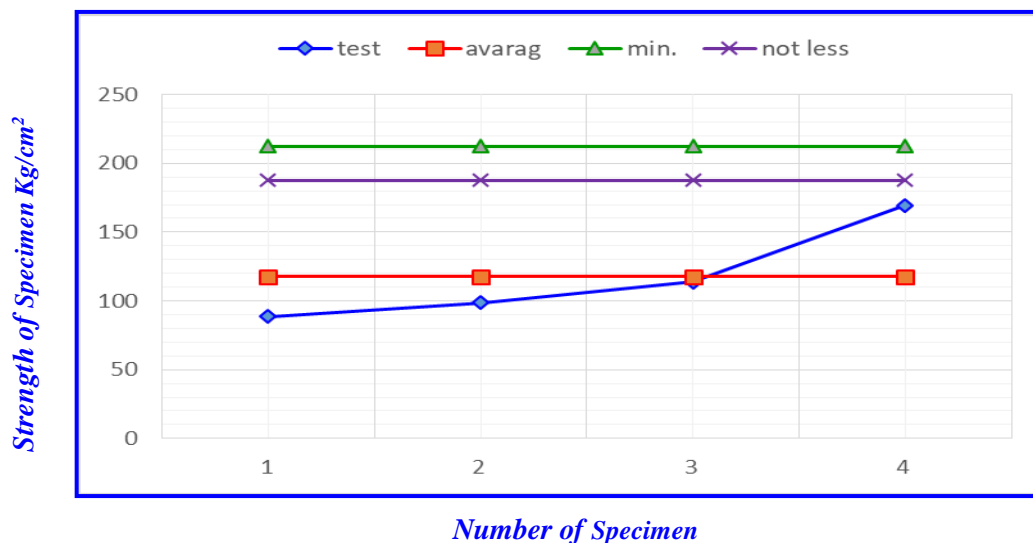
Samples CB3 and GS1 contain bars of reinforcement, which significantly affect the result, and should be taken into consideration when using it in structural analysis. The strength of GB2 beam decreases to 130 kg/cm², about 52% of the required strength (Table 1,2). The results show that the average strength of the beam and slabs samples is 188 kg/cm², which is equivalent to 75% of the imposed design strength of 250 kg/cm². It is also noted that three samples are less than 75% of the design strength imposed (Table 1, 2,3)

Tests results indicate that ground roof slab design didn't met the code ACI-318. Also, the concrete mixture test result show weakness in concrete strength, due to failure in water percentage in the mixture. It is necessary to verify the slabs in other ways as a load test (Figure 9).

Figure 9 Strength of core test, average, min., not less

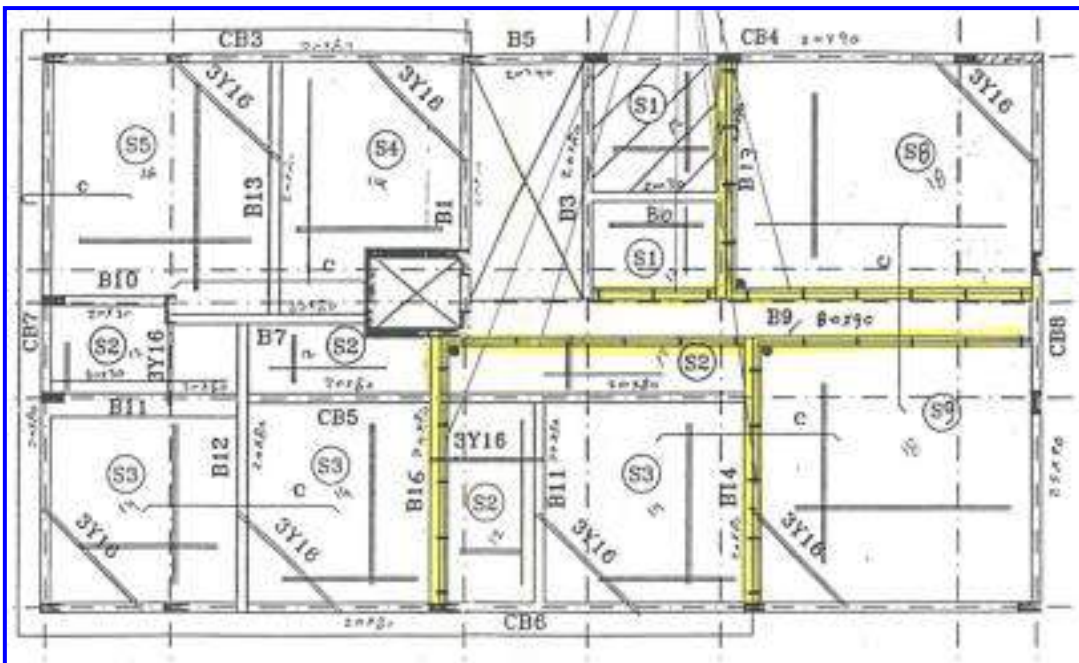
Figure 10 first floor roof slabs plan

The building consists of a basement, ground, first, second floors, and a roof with two rooms. The building was constructed as the structure shown (Figure 10)

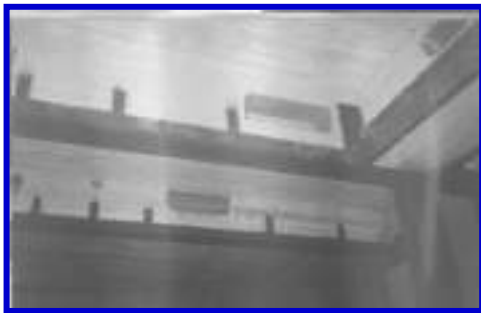
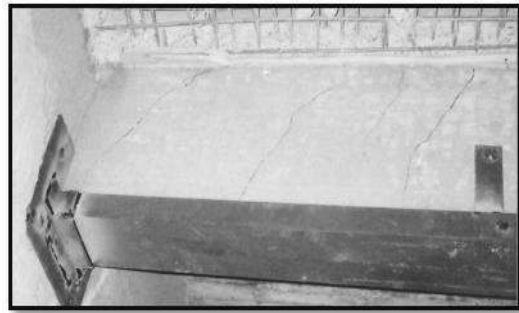
- 1.1.1. The air conditioning duct openings are near the beams support points (at the high shear points), causing fractures and cracks in these places. (Figure 11).
- 1.1.2. The concrete cover of the steel reinforcing of the beams is insufficient as the stirrups steel reinforcing have appeared from the bottom of the beam.
- 1.1.3. There are cracks around most of the air conditioning duct openings in the beams.
- 1.1.4. Nesting and voids (honey comb) in concrete
- 1.1.5. Adhesion the bars of steel reinforcing in some beams, which prevents the passage of concrete, causing a lack of cohesion between concrete and steel
- 1.1.6. There are inclined in some beams and lack of straightness (Figure 11)

Core Location

Crack in beam

Figure 11 Core Location & Cracks in beams

- 4.1.** Concrete is Non-conforming to the required specifications in the roof slabs.
- 4.2.** Poor roofs slabs implementation, where thickness of many slabs does not match the drawings, causing distortions and large cracks in slabs.
- 4.3.** Poor installation of steel bars, where the required distances between the bars were not considered, which led to a weak link between the concrete and steel, where voids occurred in concrete.
- 4.4.** Lack of sufficient concrete cover for many structural elements
- 4.5.** Un satisfactory fitting of air-conditioning openings, especially in the high cut points of beams.

- 5.1.** Due to the weak of concrete and many cracks in the slabs of the ground and first roof, it must be demolished and re-poured, with proper reinforcement procedures that extend to adjacent slabs.
- 5.2.** Strengthening the identified beams, using appropriate steel section, and strong adhesive materials like (epoxy materials).
- 5.3.** Reinforcing the defected columns with appropriate steel sections.
- 5.4.** Apply epoxy layer to the old concrete faces where they are bonded with the new concrete before casting directly [15].

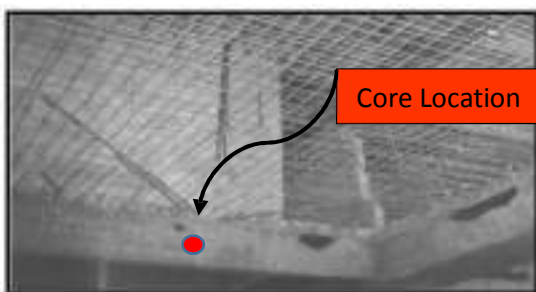
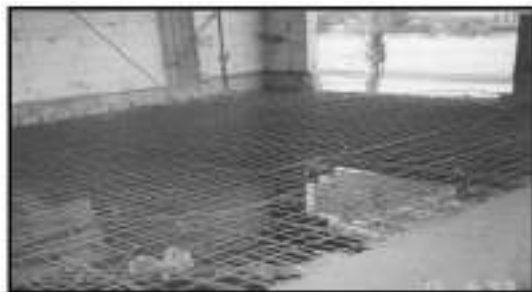
- 1.2.1. The presence of water in many areas in most of the slabs, indicating the presence of cracks and deep fractures on the whole thickness of the slab
- 1.2.2. There are cracks and cracks up in some places to display 2 mm
- 1.2.3. There is a large deflection in the floors of the first floor (roof of the ground floor) up to 5 cm in slabs S5, S8 and S9 in addition to the presence of deep and many cracks on the perimeter of the slab sometimes reach the full thickness of the slab (Figure 12)

Figure 12 Slabs S9, S8 after demolishing

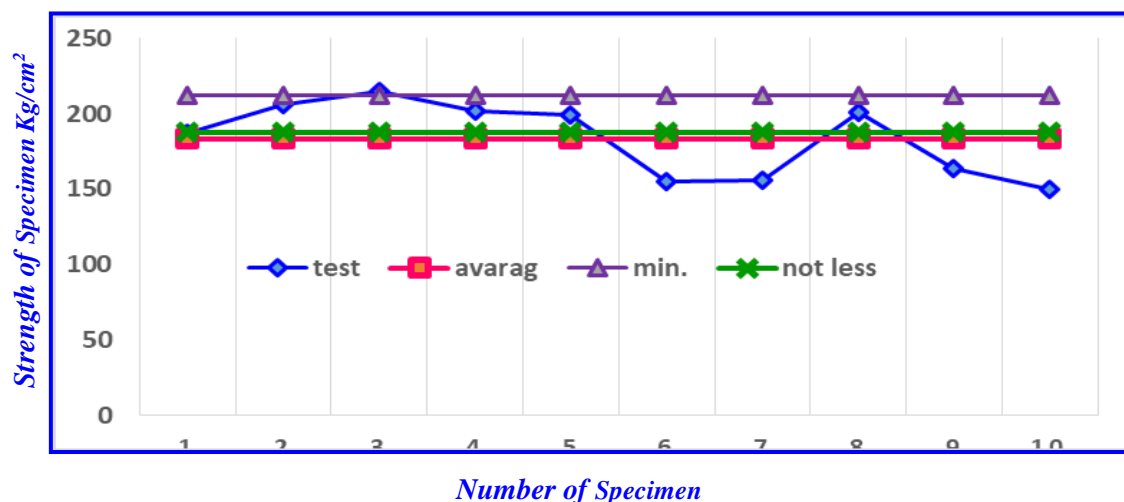
- 2.3.1. Beams: The reinforcement ratio of some beams is greater than the permissible, reinforcement ratio according to ACI-318, which makes the method of failure surprising (Brittle mode of failure) in the case of increasing the stresses of what the structural elements
- 2.3.2. Slabs: In the ground and first floor the slabs (S5, S8, S9) are unsafe structure. Table (5,7), Figure 13

Figure 13 Strength of core test, average, min., not less

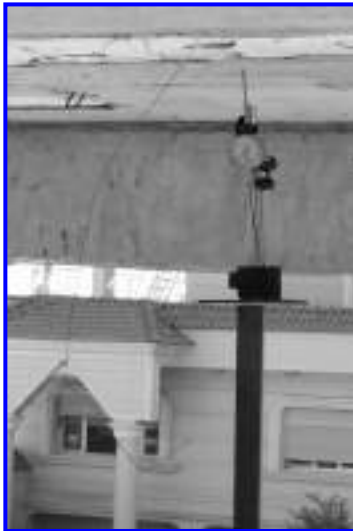
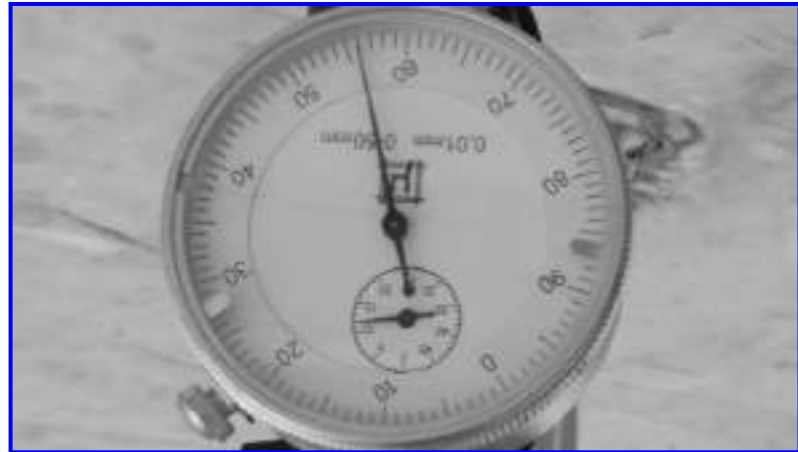
- Dial gauges with magnetic base, installs into the slab structure in several points, where dial gage no.3 (G1) is installed at the middle of the slab. (Figure 13).
- Initial deflections, and temperature prior the testing should be recorded.
- Load should be increased gradually (0% - 25% - 50% - 75% - 100%) of the maximum load, while each load stage held for 1 hour, and for the maximum load (100%) it should held for 24 hours.
- After 24 hours, load is decreased gradually (100%- 75%- 50%- 25% - 0%)
- each released stage is held for 1 hour, and after releasing all load it must held for 24 hours.

Figure 13 Digital gauge and magnetic holder

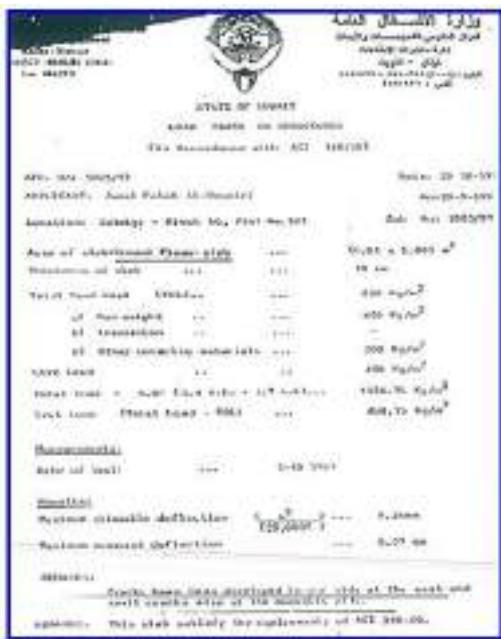
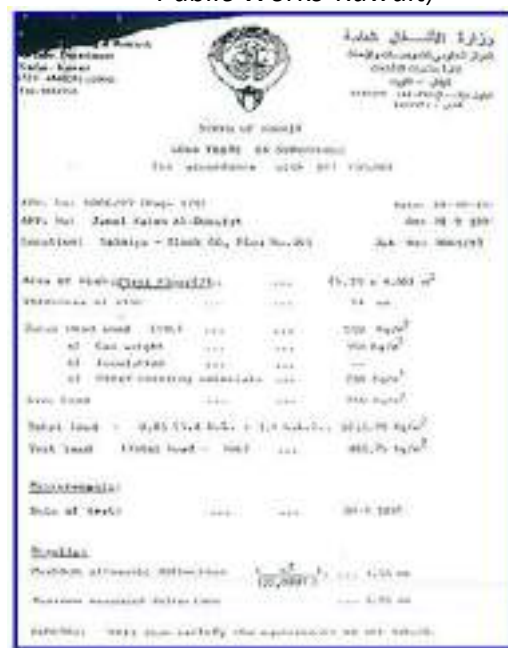
(The load test was carried out by the Government Inspection Center of the Ministry of Public Works-Kuwait)

Figure 14 Ministry of Public work inspection reports

After the test, cracks have been developed in one side and smaller one at opposite side. Deflection values that occurred after the tests was acceptable according to the ACI-318 code. The ratio of the existing reinforcing steel is greater than the maximum percentage, it indicates that the concrete strength will reach its maximum value before the steel reaches to the yield point.
